The floods in Bari: What history should have taught

MICHELE MOSSA, PhD, Professor, IAHR Member, A.M. ASCE, DIASS, Technical University of Bari,
Via E. Orabona 4, 70125 Bari, Italy. Tel.: +39 080 5963289; fax: +39 080 5963414; e-mail: m.mossa@poliba.it

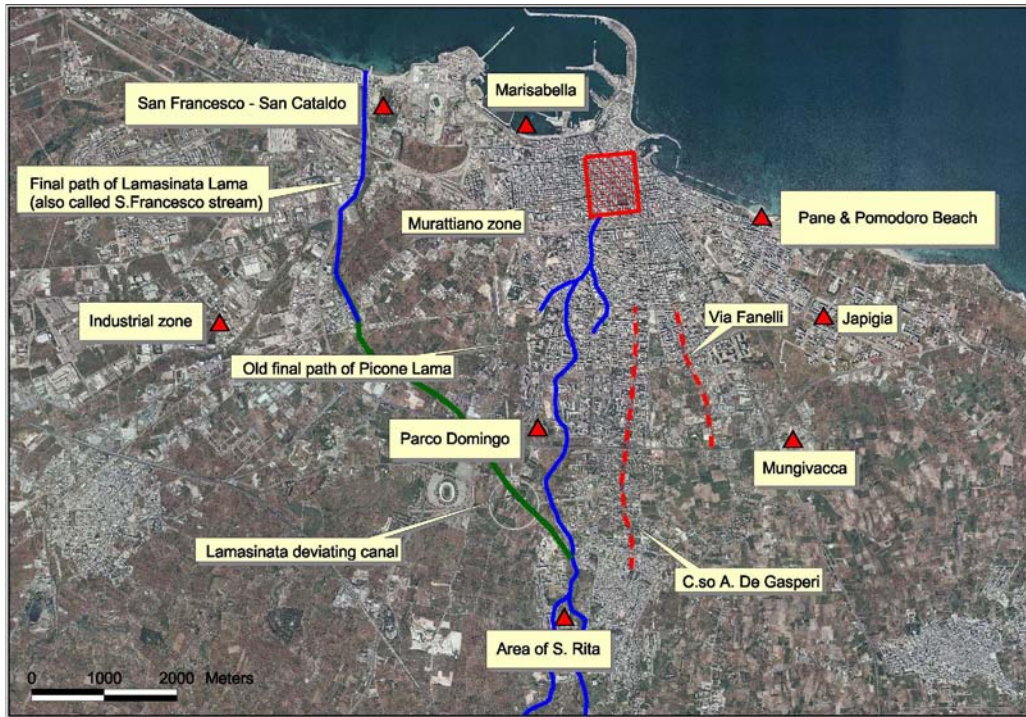
Figure 3 Satellite map of city of Bari with some points of reference.

- (iii) The Villa Lamberti Lama (no. 3, Fig. 2a and 2b) is relatively small and takes the name of an 18th century villa. It originates just west of Bitritto and continues on until the zone called Marisabella (Fig. 3), where the new Port of Bari currently arises.

- (v) The Fitta Lama (no. 5, Fig. 3) is on the east side of a valley and the Picone Lama is on the west side, with the towns of Loseto and Ceglie between these streams. It descends towards the sea, adjacent to Corso Alcide De Gasperi and Via Fanelli streets (Fig. 3), ending at the “Pane

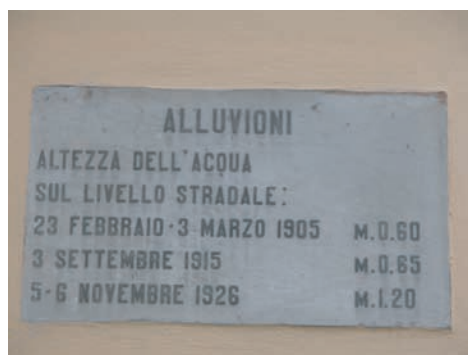
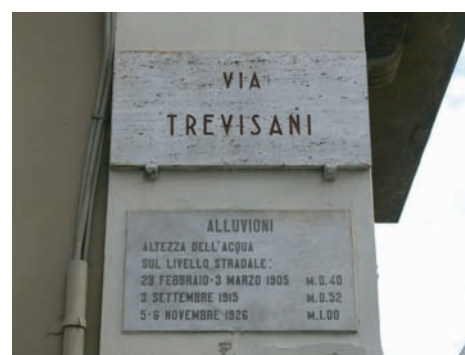
(a) Via Murat – Via Trevisani crossroad.

(b) Via Trevisani – Via Garruba crossroad.

Figure 4 Two of the stone tablets of Bari remembering the floods of 1905, 1915, and 1926.

mentioned stone tablets and Fig. 5 shows the principal roads in Bari's Murattiano zone and neighbourhood. Table 1 shows the values of water heights observed on the streets in Fig. 5, as indicated from the stone tablets in Fig. 4.

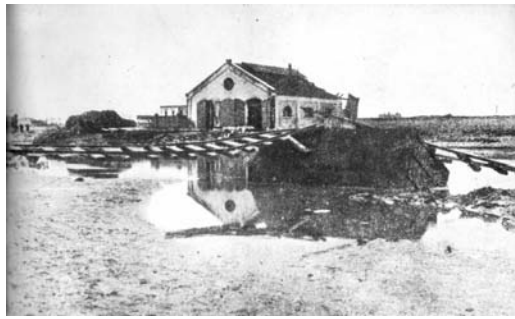
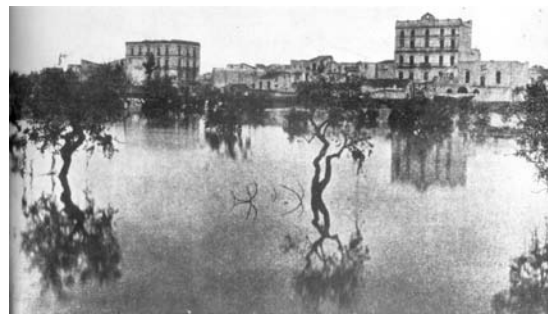
(a) Railway Bari-Barletta.

(b) Via Crisanzio.

Figure 6 Photos of the flood in 1905 (courtesy of Melchiorre, 1982).

the area of Via Manzoni (Fig. 5) along the southwest slopes of the city, making an unstoppable course towards the sea, sweeping away, with unprecedented violence, all that was in its path. The flood waters poured over parallel streets of Via Sagarriga Visconti, Via Quintino Sella, Via De Rossi and also onto the sidestreets of Via Crisanzio, Via Garruba, Via Dante, Via Putignano, and Via Calefati (see Fig. 5), submerging a large surface under mud and debris. On March 3, heavy rains produced a new flood, smashing down on the city affecting the same zone. Fortunately, even greater disaster was avoided by opening a temporary canal to divert the flood's path and erecting a levee at the mouth of the Picone basin in the direction of Via Manzoni. The photos in Fig. 6 (by Melchiorre, 1982) show the effects of the 1905 flood.

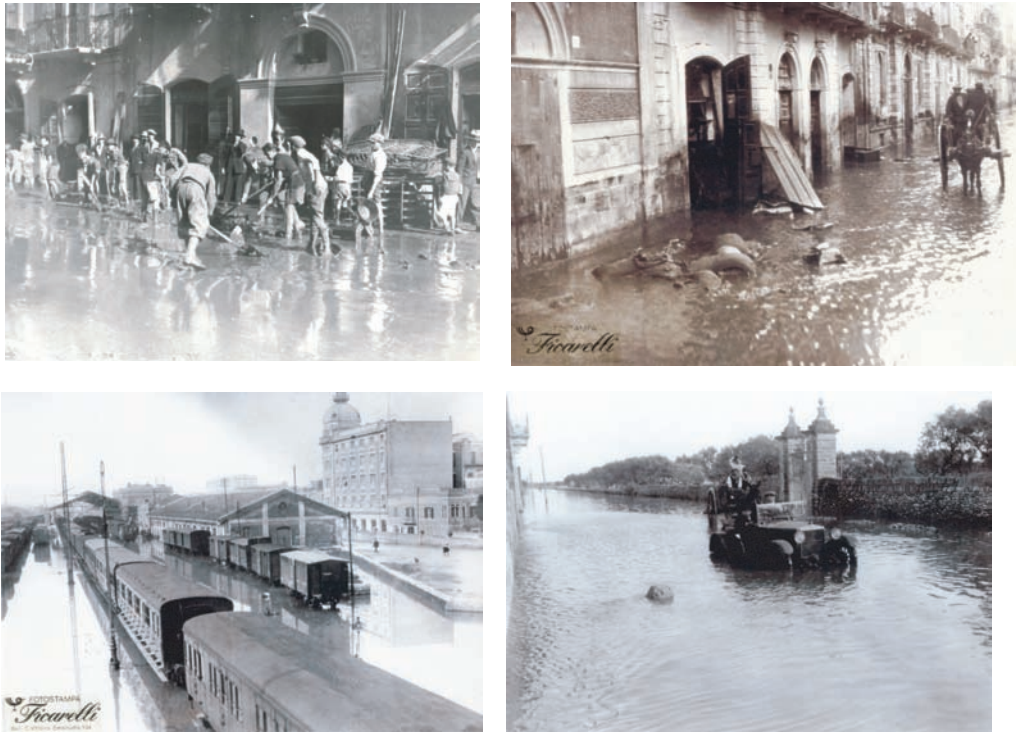
Figure 9 Photos of the flood in 1926 (Fotostampa Ficarelli, Bari).

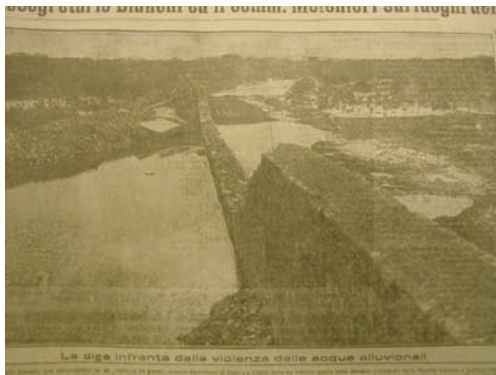
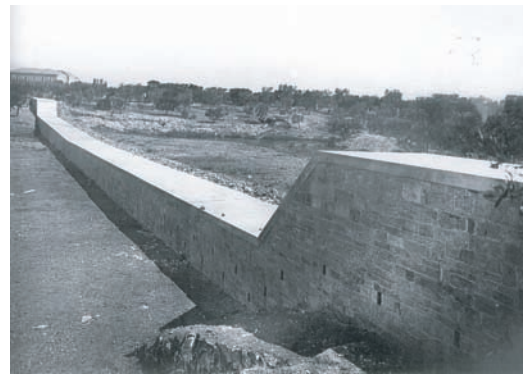
(a) The Picone levee (see Fig. 7) after the 1926 flood (from La Gazzetta di Puglia, 1926).

(b) The reconstruction of the Picone Levee after the flood of 1926 (courtesy of Melchiorre, 2000).

Figure 10 The Picone levee damaged after the flood of 1926 and subsequently reconstructed. See Figs 3 and 7 for the Lamasinata deviating canal and the Picone levee.

In conclusion, the origin of this disaster can be imputed exclusively to the collapse of the barrier levee, whereas the Picone collector and the sewers helped in diminishing even more damage. However, the collapse of the barrier was not the only consequence of the disaster. The number of victims and damage was also due to the common dwellings which were built on the ground floor facing the street, and, in violation of the regulations. The morning of Sunday, November 7th, the final account of victims was made, a total of 20 dead. The event resonated so loudly in all of Italy that many cities, including Rome, Naples, Milan, Florence, immediately sent their fire departments to help. Figure 9 shows some photos of the 1926 flood. The Italian government sent the Minister of Public Works to evaluate the essential nature of damage and to implement the most urgent measures to be taken. Amongst other things, enlarging the width of the Picone Stream by 34 m, moving the last trunk of the Lamasinata Lama towards

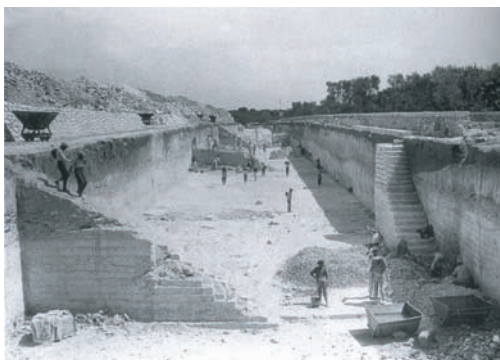
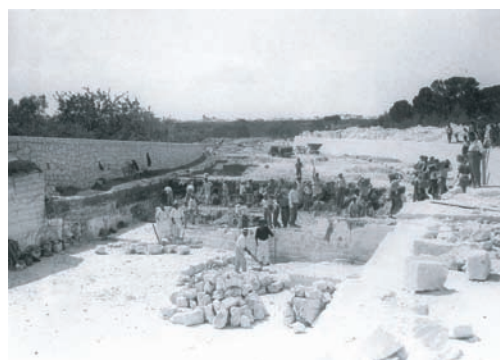
Figure 11 Reconstruction work after the 1926 flood. Deviation of Montrone Lama in Valenzano Lama (courtesy of Melchiorre, 2000).

the west as well as deviating the Montrone Lama (which is the stream flowing through Adelfia, Fig. 2a and 2b) in Valenzano Lama (Fig. 11), and reconstructing the outlet of the Valenzano Lama at the sea were considered. In addition, a forestation of a large area upstream of the Picone catch basin, corresponding to the current Mercandante forest (in Cassano delle Murge, Fig. 2a and 2b) was planned. Figure 10 shows the Picone Lama levee after the 1926 flood and after reconstruction (for the location of this levee see Figs 3 and 7). The photos in Fig. 11 show different phases of the said protective operations carried out in Bari after the 1926 flood.

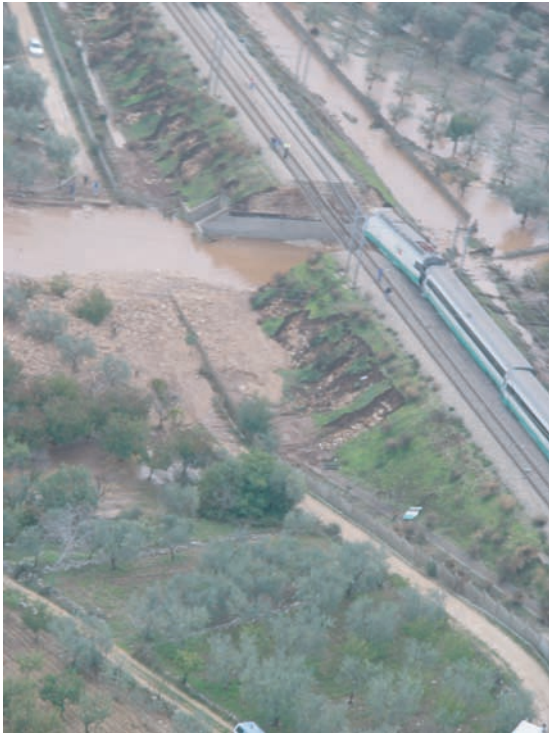
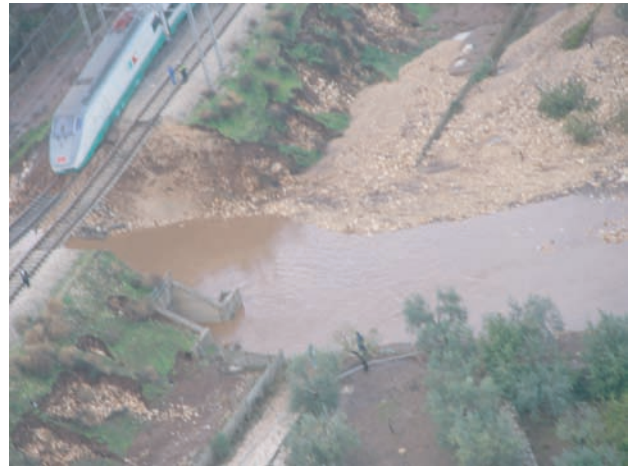
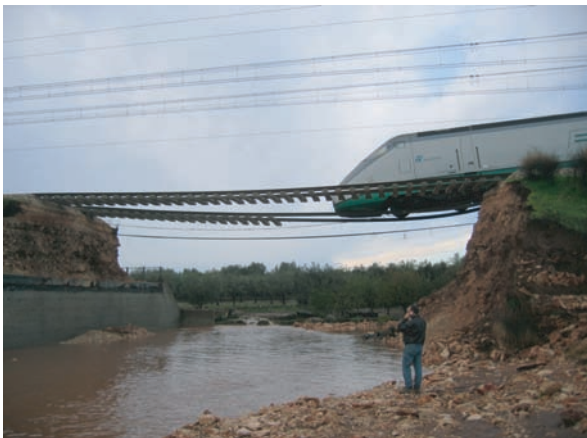
(a) Derailed Eurostar train.

(b) Derailed Eurostar train. It is evident the undersized culvert.

(c) Derailed Eurostar train.

Figure 12 The effects of the flood of October, 2005 (the location of these zones are described in the text and see Fig. 3).

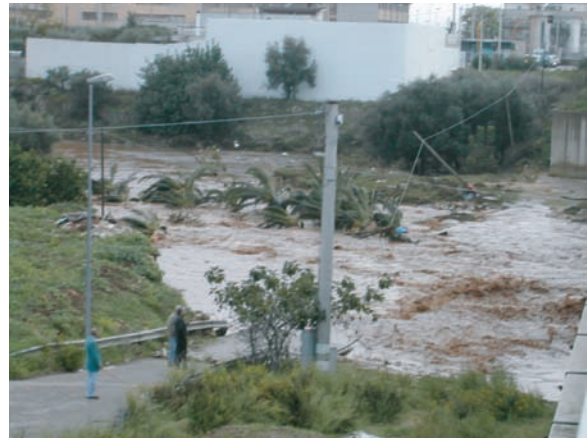
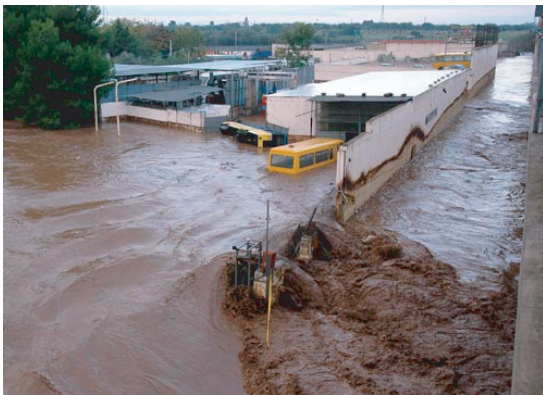
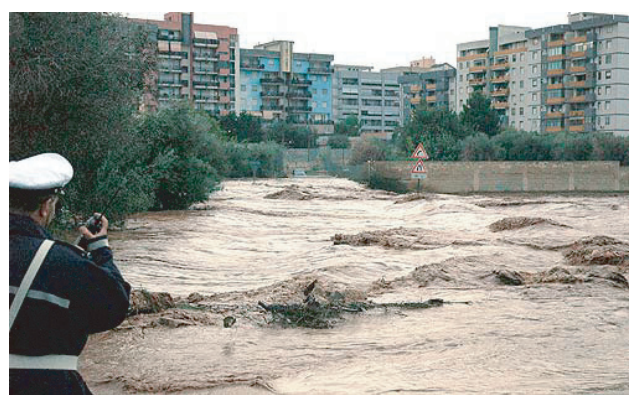
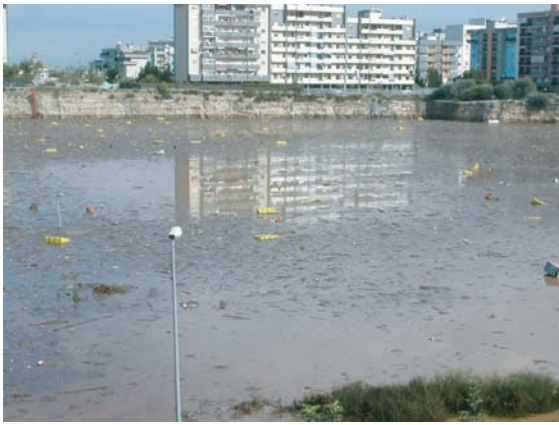
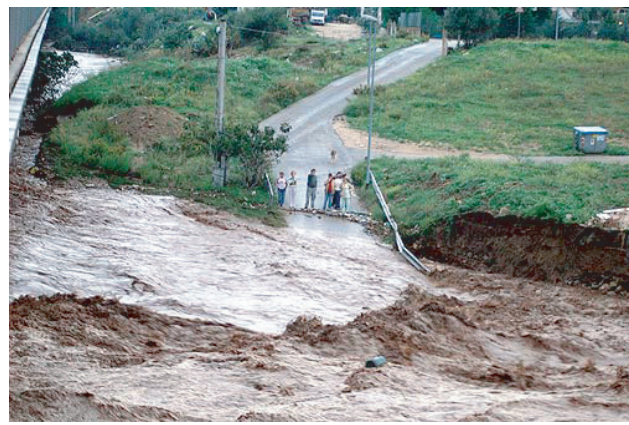
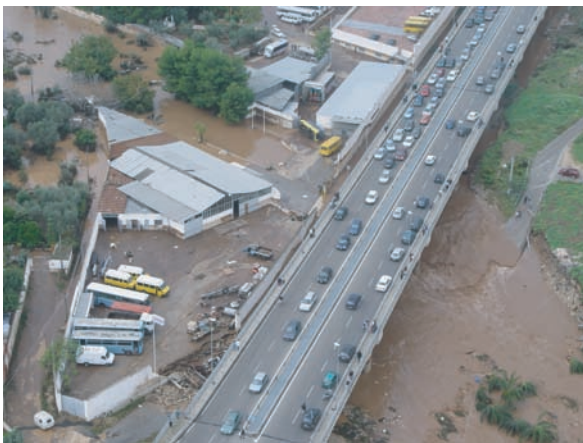
(d) Area of S. Rita di Bari.

(e) Area of S. Rita di Bari. Bus warehouse.

(f) Area of S. Rita di Bari. Channel underflooding.

(g) Area of S. Rita di Bari. Ex-quarry DiMaso.

(h) Area of S. Rita di Bari. Road destroyed by flood.

(i) Area of S. Rita di Bari.

this story has not taught us anything. These muddy rivers, the homes built on the canal beds (Fig. 12d), this panorama of floating debris (Fig. 12h–12i), of horrors scattered among cement cubes is the result of man, who disobeys the hydraulic nature of

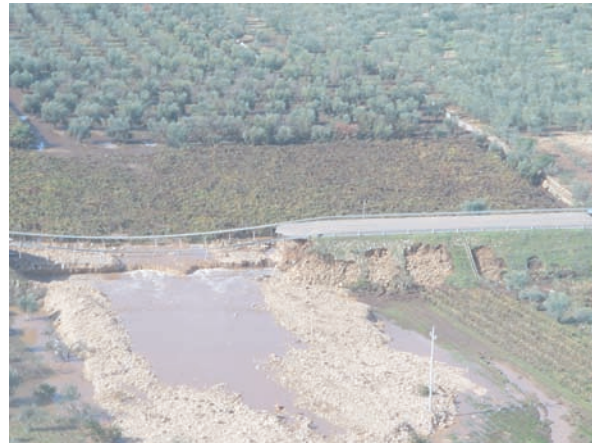
(j) Collapse of a road embankment between Cassano delle Murge and Bitetto.

the territory. The torrential rain is enough to split an embankment in two, tear up illegally constructed streets, to destroy a public park built inside a quarry in Carbonara (Fig. 12g), to drown many small residential towns created in the last years,

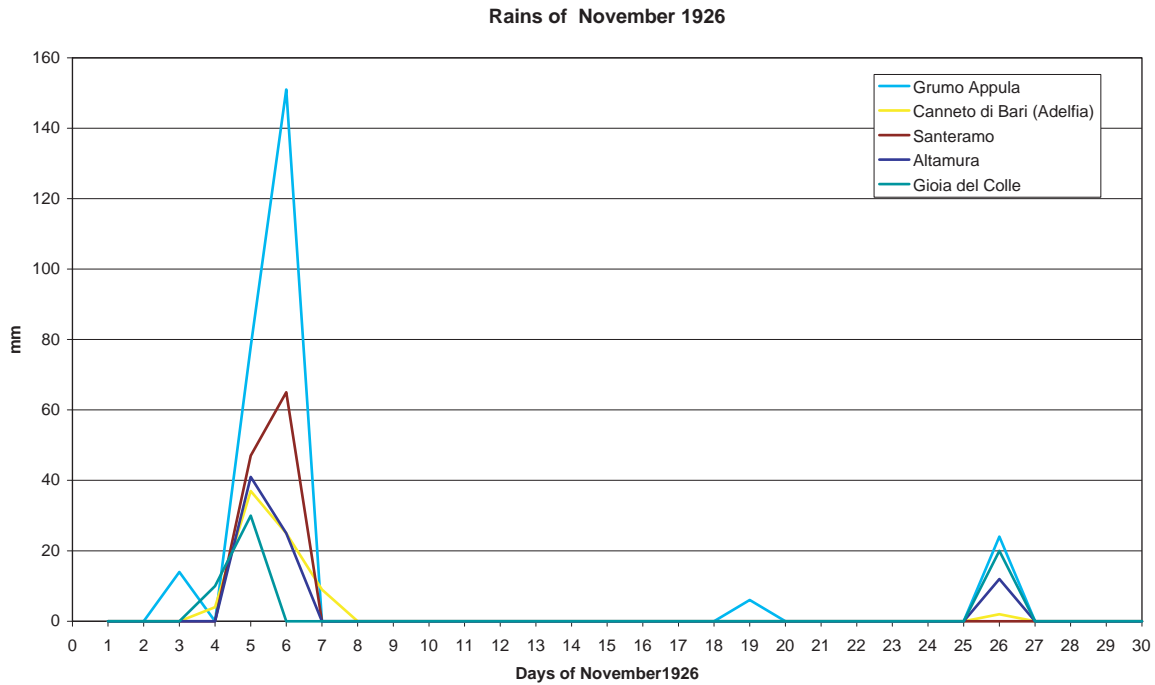
Figure 13 Daily rains of Novembre 1926.

As read in the Annals of Hydrology, the rains of November 5–6, 1926 caused a flow in the basins of the Lamasinata, Picone, Montrone and Valenzano Streams of $1.8 \text{ m}^3 (\text{sKm}^2)^{-1}$. In Bari there was a 24 h precipitation of 103.0 mm (5 November 1926) and a 48 h precipitation of 160.0 mm (5–6 November 1926), which represented the maximum values seen then. The average hourly rainfall intensity was measured at 21.7 mm h^{-1} . Figure 13 shows the data of daily rainfall at different weather stations (Fig. 2a and 2b) involved in this meteorological event. It is observed that the peak daily rainfall measuring 151 mm, occurred in Grumo Appula on 6 November 1926.

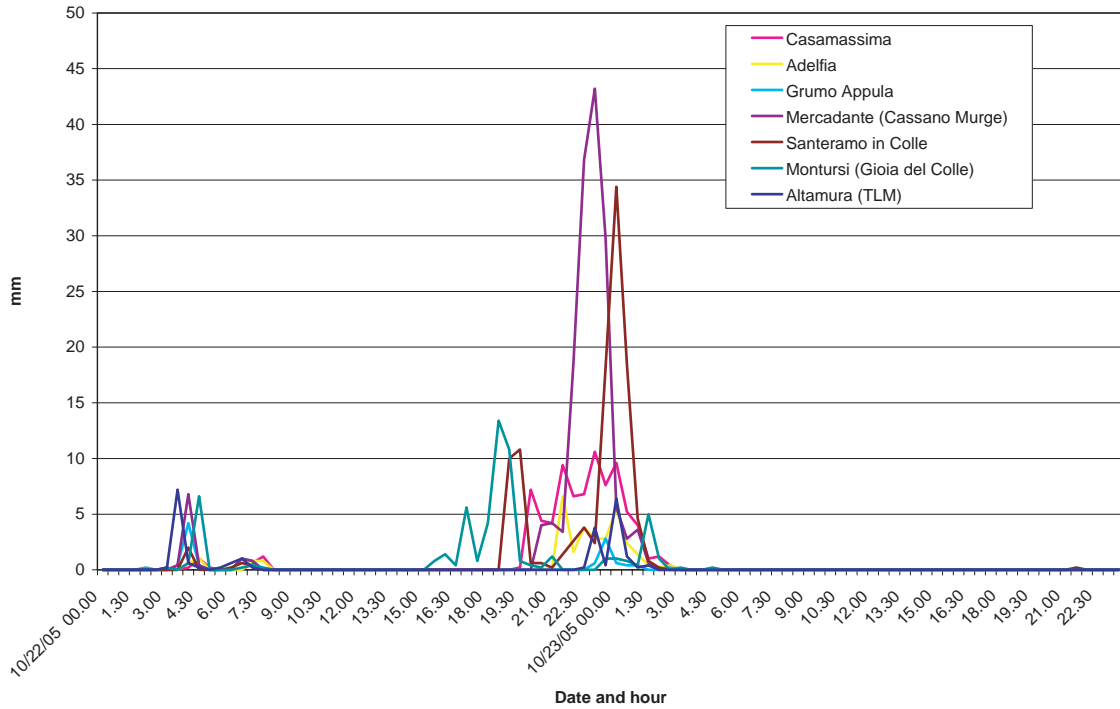
Figure 15 Thirty minute measurements of rainfall between October 22–23, 2005.

Regarding the flood of October 2005, Fig. 15 shows 30 min. measurements of rainfall between October 22–23, 2005, while Fig. 16 shows daily rainfall in October 2005. From the analysis of both figures, it is observed that the maximum quantity of rainfall was registered at the Mercadante (Cassano delle Murge) and Santeramo in Colle weather stations the night between 22 and 23 October, 2005 with maximum 30 min. measurement values of 43.2 and 34.4 mm, respectively, and maximum daily values of 149.4 and 53.8 mm respectively. Figure 17 report the depth-duration-frequency curves together with maximum precipitation intensity of November 5, 1926 and of October 22–23, 2005 and the historical maxima measured until the year 2000 at the weather stations that possess the records. The depth duration frequency curves with return time of 30, 200 and 500 years are obtained starting from a minimum observation of 30 years and a maximum of 48 years. It is hypothesized that the observations were described by Gumbel's probability distribution function.

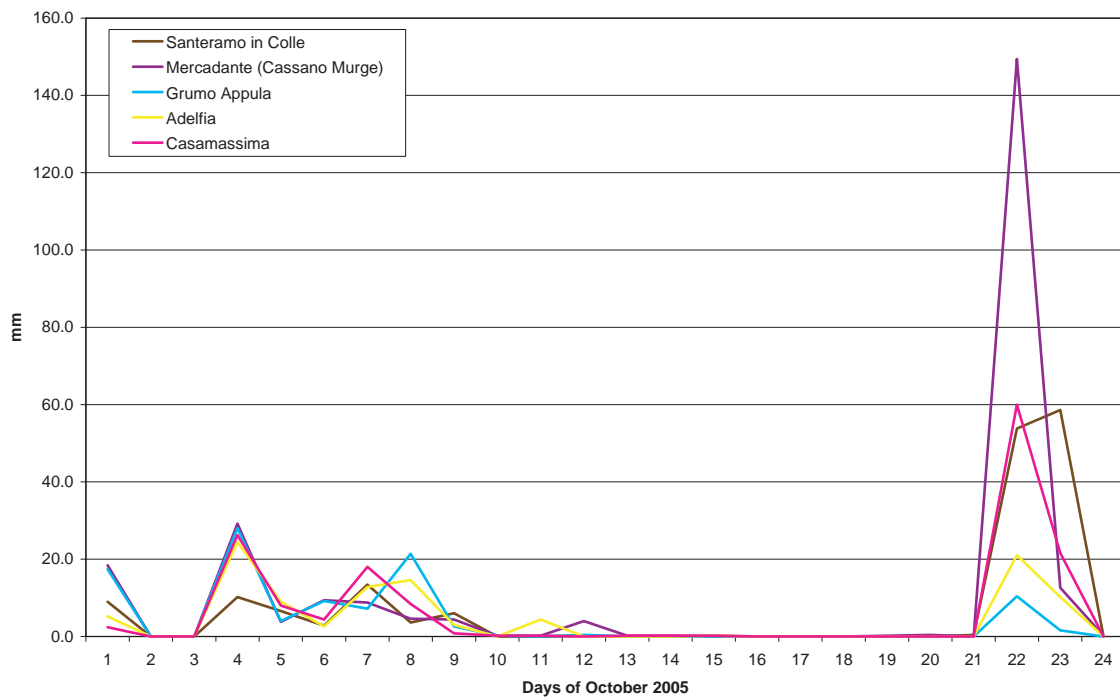
Figure 16 Daily rainfall in October 2005.

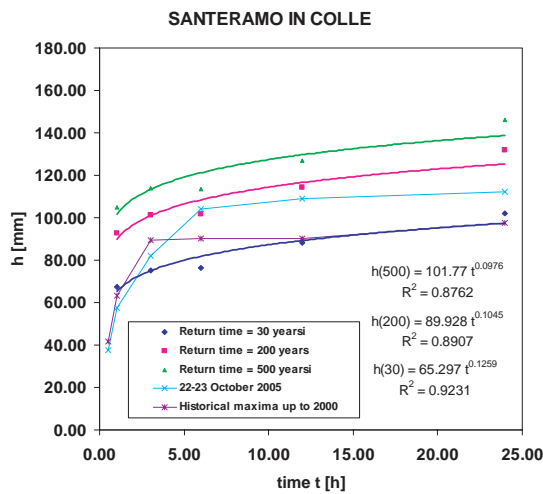
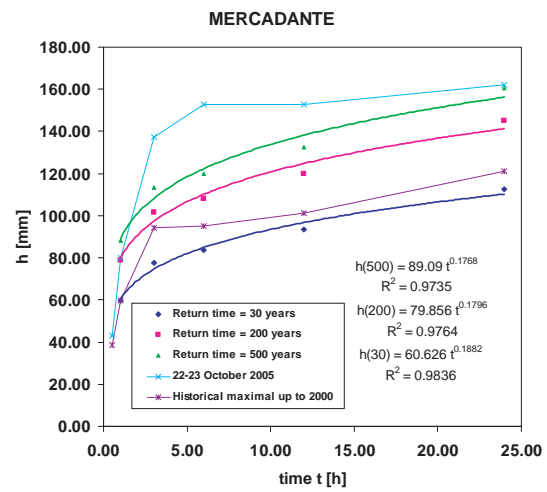
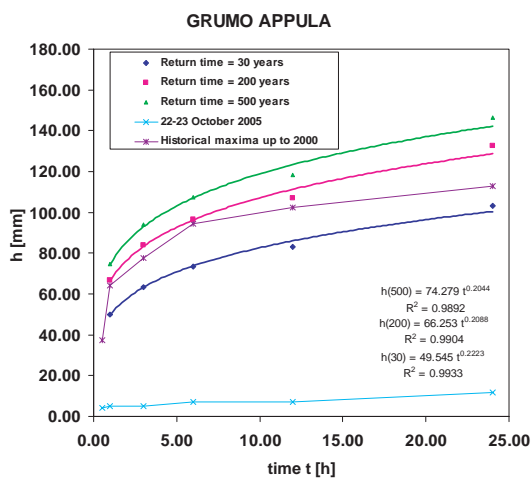
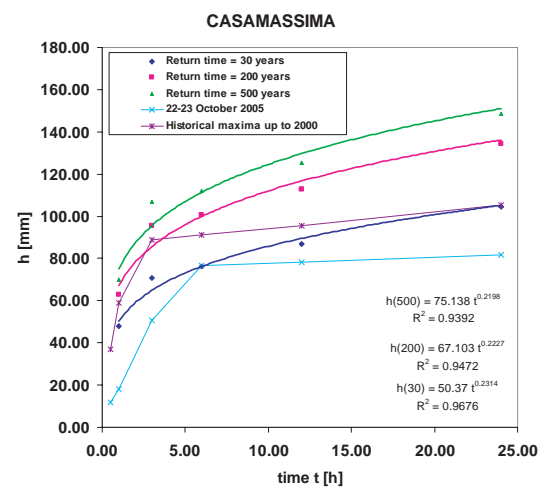
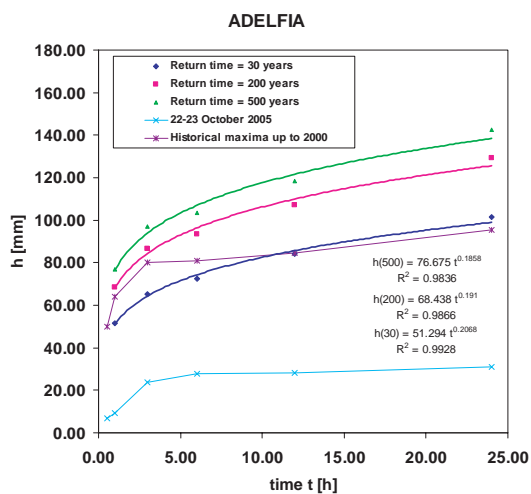
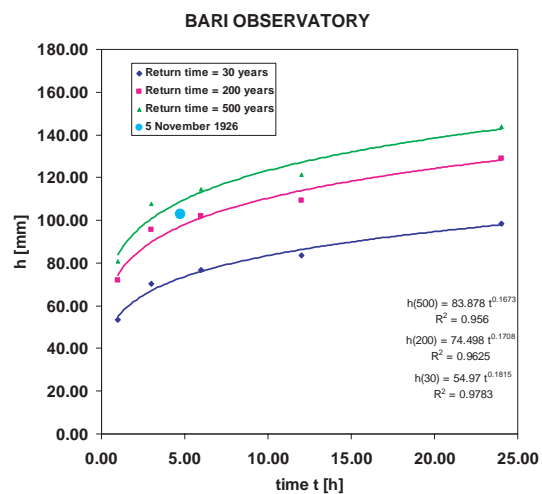
Figure 17 Depth duration frequency curves together with maximum precipitation intensity of November 5, 1926 and of October 22–23, 2005 and the historical maxima measured until the year 2000.

One considerable observation is that the 103 mm of rain which fell on Bari on November 5, 1926 between the hours of 19:00 and 23:45 was extremely unusual, having a return time of more than 200 years. Regarding the flood of 2005, this rare behavior was evidenced at the weather stations in Santeramo in Colle and, above all, at Mercadante (Cassano delle Murge), while at other stations the rainfall was characterized by a return time less than 30 years and in many times, even shorter.
